# Richmond Refinery LPS Bulletin – Safety #4 Crude Unit Fire- (11/14/2011)

**Location: #4 Crude –  
Distillation and Reforming  
Division**

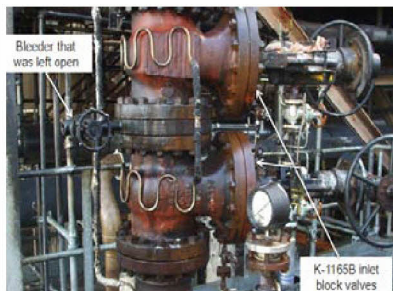
Bleeder that was left in the open position

- 1) The operations crew that was on the shift prior to the incident had performed work on these filters and the bleeder valve was left in the open position. This condition was not communicated by the previous shift to the next crew on duty.
- 2) Current Job Aids for these filters did not specifically address the work that was being performed during startup conditions.
- 3) When operators in the field reviewed the conditions of the filters before beginning the task, the open bleeder was not identified. It was noticeably dark in the area.

- 1) After completing a task, verify that all of the valves are in the correct position before leaving the job.
- 2) Communicate the current conditions and any other relevant information regarding the area or project to next shift so that they can address any current condition, including any abnormal or out of the ordinary situation.

- 1) Consider methods for improving Operator turnover during plant startup and shutdown periods so that the necessary and appropriate information is communicated by on shift to the next shift.
- 2) Consider developing a procedure that will cover switching filters during a plant startup where conditions are different than normal operations
- 3) Conduct a lighting survey of the area where this incident occurred to determine if additional lighting requirements are necessary.
